**A STUDY ON BEACH PROTECTION USING NAHRIM  
COASTAL PROTECTION AND EXPANSION (NEXC)  
BLOCKS SYSTEM FOR PANTAI BATU 5,  
PORT DICKSON, NEGERI SEMBILAN**

Dissertation submitted to in partial fullfilment  
of the requirements for the degree of  
**Master of Science**

**Faculty of Civil Engineering**

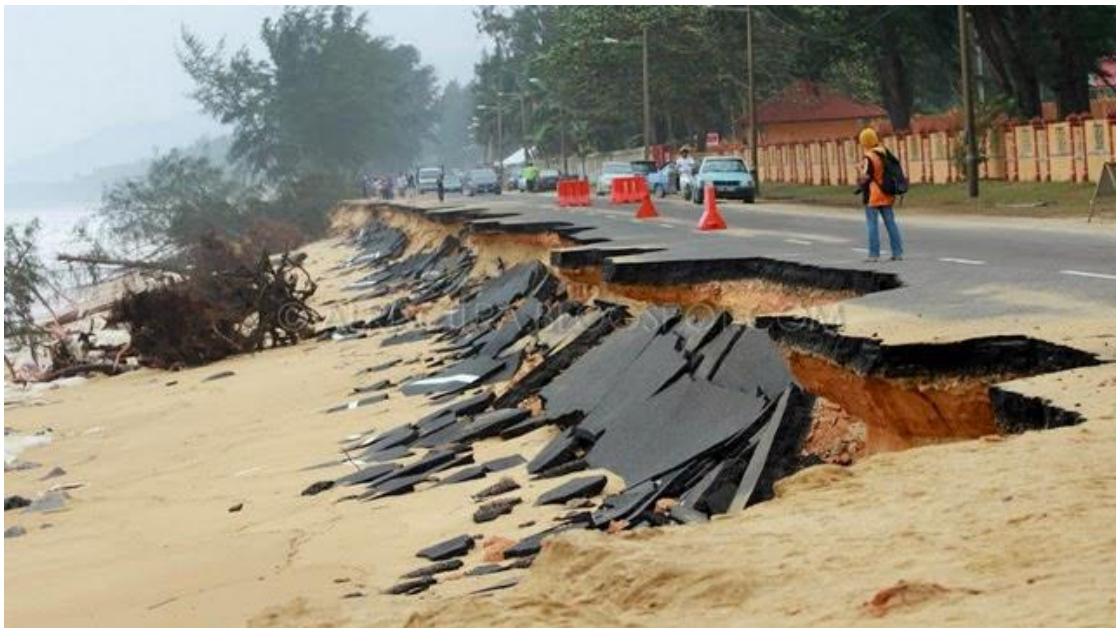
Figure 2.3 : Severe coastal erosion occurred in Teluk Lipat, Dungun, Terengganu just after the North-East Monsoon due to the destructive wave action.

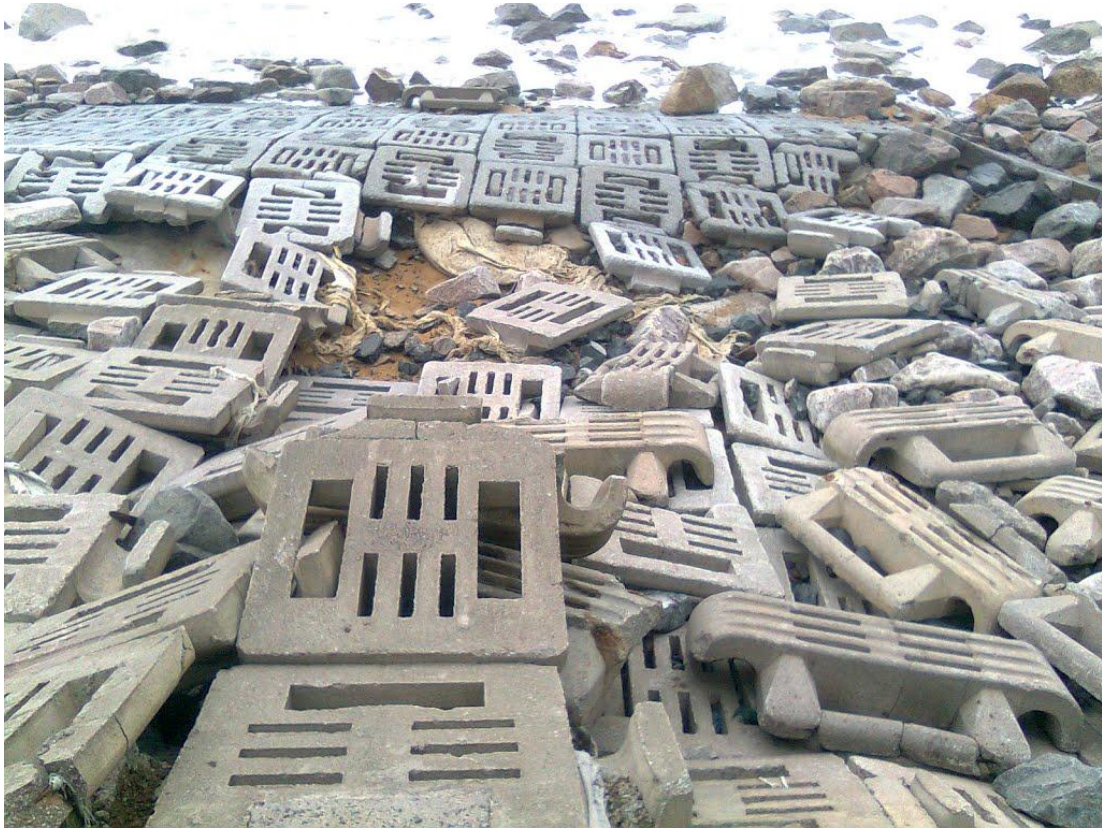
Figure 2.15 : The failure condition of interlocking flex-slab revetment after being hit by big waves at Pantai Teluk Lipat, Dungun, Terengganu (source : DID, 2009)

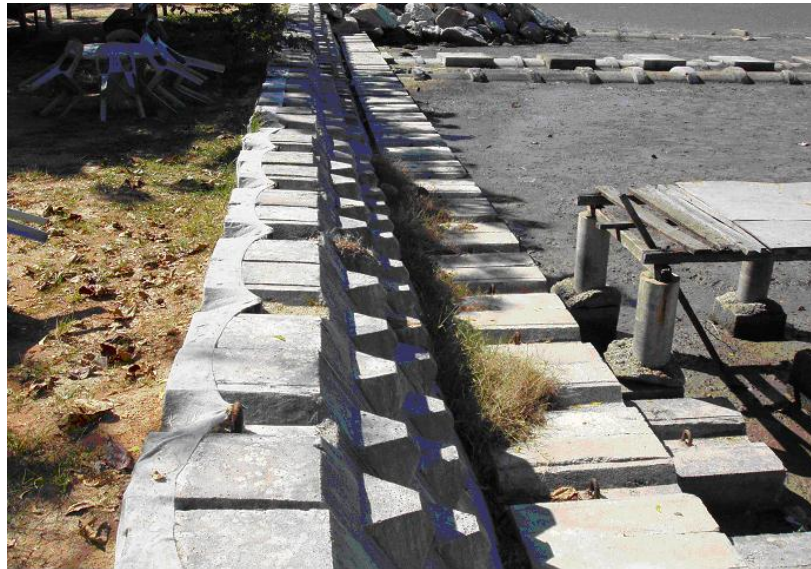
Figure 2.27 : Second Generation of Labuan Blocks as sloping “mattresses” at Taman Robina, Seberang Perai Utara, Pulau Pinang (source : DID, 2009)

Additional modifications in the form of trapezoidal buttons have been introduced to the original smooth-faced design to reduce run-up for the second generation (refer to Figure 2.27).

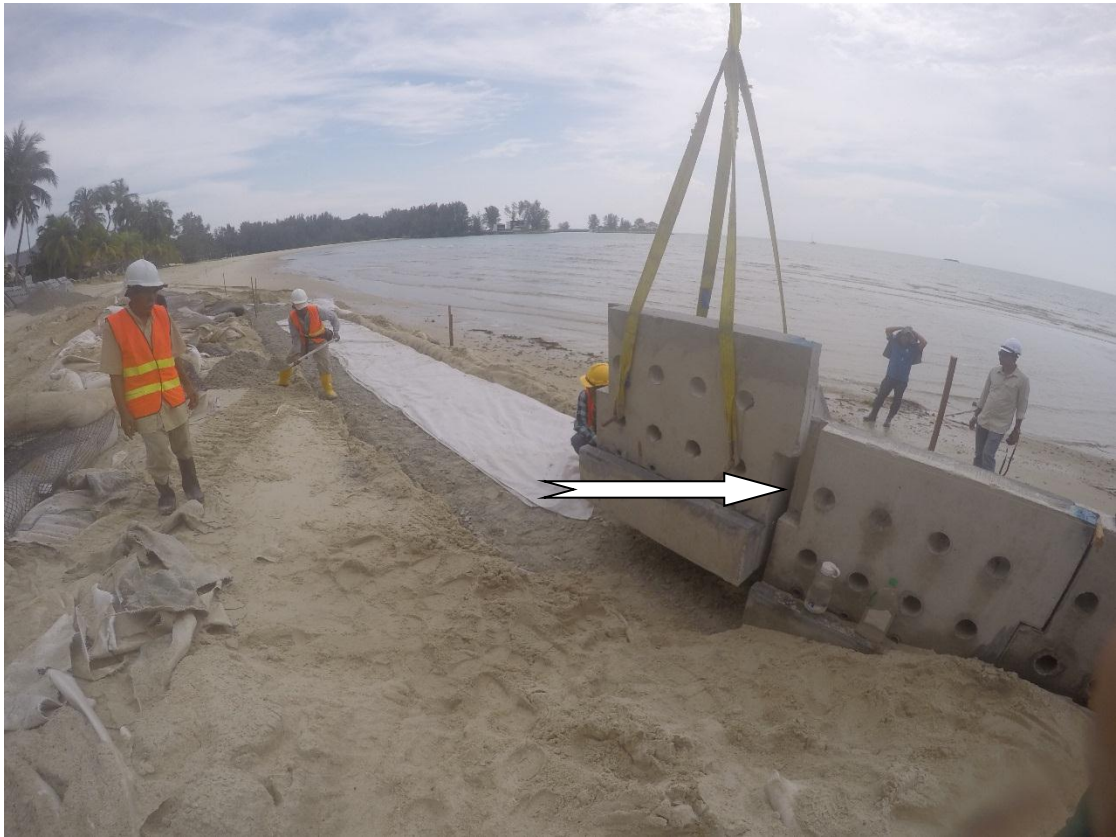
Figure 3.9 : The arrow shows slotted (male connector) and grooved (female connector) interlocking designed for NEXC Blocks System (source : NAHRIM)

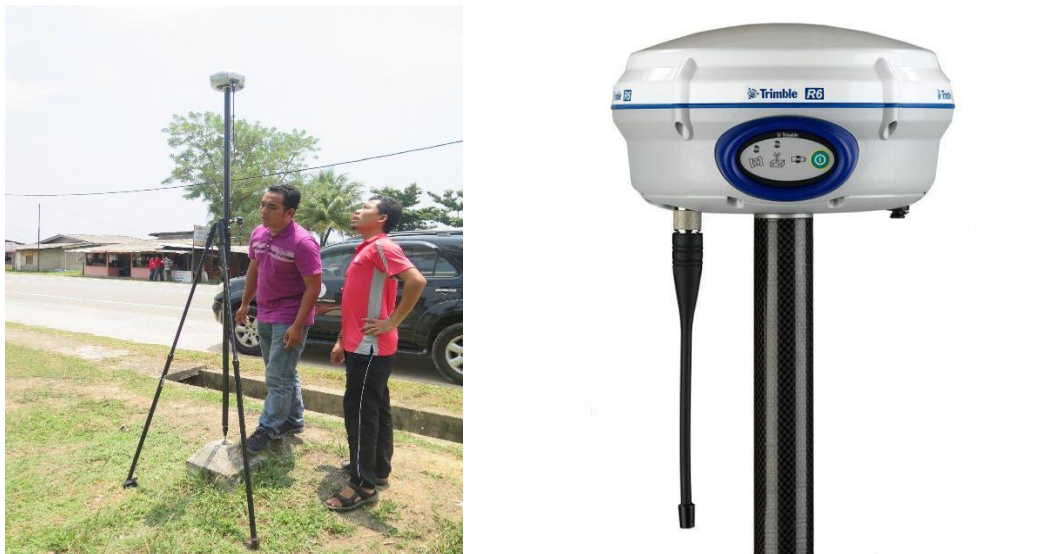
Figure 3.10 : Beach profiling survey by using RTK Method and instrumentation (left picture). The RTK Device : Trimble R6 (High Resolution) GPS Receiver (right picture) (source : NAHRIM)

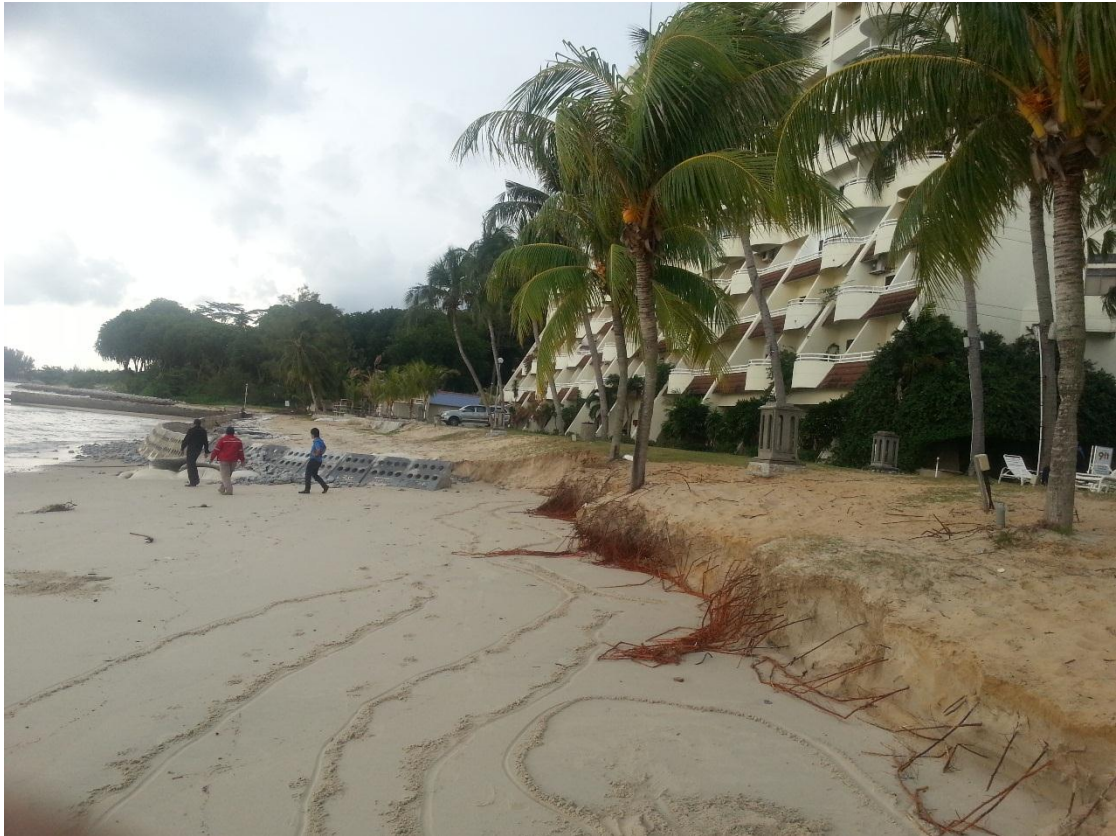
Figure 3.41 : Severe erosion occurred at the end of the chainage 108m of NEXC Blocks System and afterwards after the Southwest Monsoon season  
(source : NAHRIM)

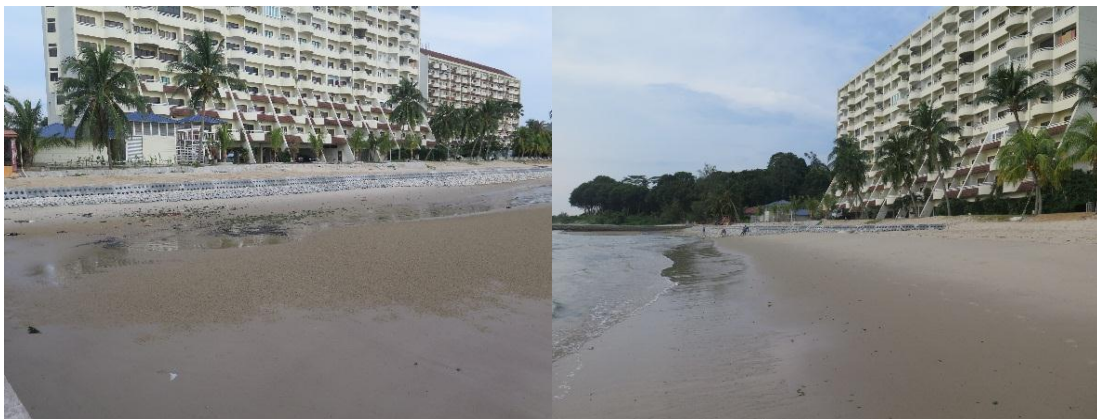
Figure 4.65 : Test site on 21 November 2015, additional scour protection at toe (source : NAHRIM)

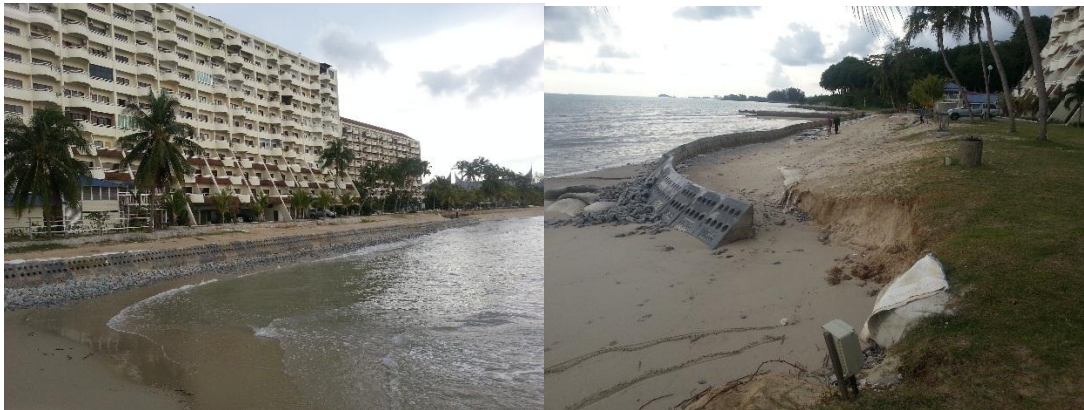
Figure 4.66 : Test site on 20 July 2016, erosion problem occurred at the end of the product alignment (source : NAHRIM)

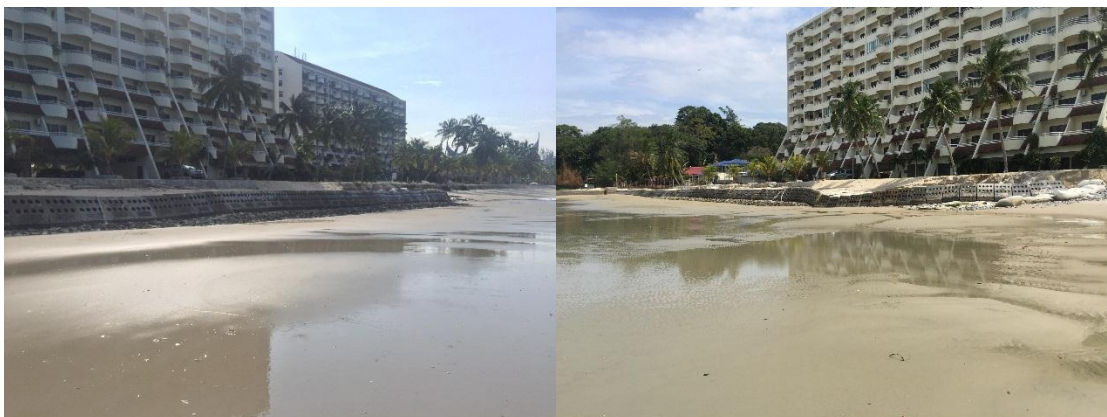
Figure 4.67 : Test site on 14 October 2016, a few blocks of the product settled due to scouring of old piping structure underneath. Severe erosion problem occurred at the end of the product alignment and afterwards (source : NAHRIM)
