## INSTITUT PENYELIDIKAN AIR KEBANGSAAN MALAYSIA (NAHRIM)

### Technical Report

### Sonar Mapping Survey at Kemaman Port Areas

**Ir. Ts. Muhammad Rizal Razali**  
Coastal and Oceanography Research Centre  
August 2024

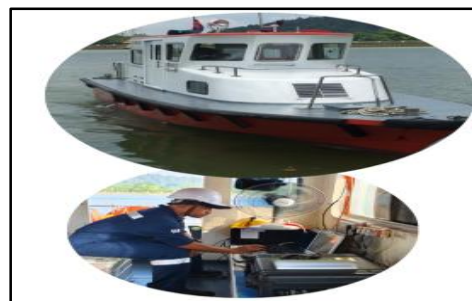
Figure 5. Survey Boat

Noor PL 2 was configured specifically for the survey task, with necessary modifications to accommodate the deployment of the **towfish sonar unit**, **Differential Global Positioning System (DGPS) antennas**, and **data acquisition systems** on board. The vessel's deck was organized to allow for the safe launch and retrieval of the side scan sonar towfish, ensuring smooth and uninterrupted operation during data collection. In addition, mounting points for DGPS antennas were carefully positioned to minimize multipath interference and ensure optimal signal reception throughout the survey. The operational characteristics of the vessel, including its manoeuvrability and stability, played a key role in maintaining consistent survey lines and ensuring data quality. Given that side scan sonar imagery is highly sensitive to vessel motion—especially yaw, pitch, and roll—it was essential that the survey boat be capable of maintaining steady headings and speed throughout each transect. Noor PL 2 provided the required performance in this regard, even under moderately challenging sea conditions caused by seasonal southeast winds during the time of the survey.

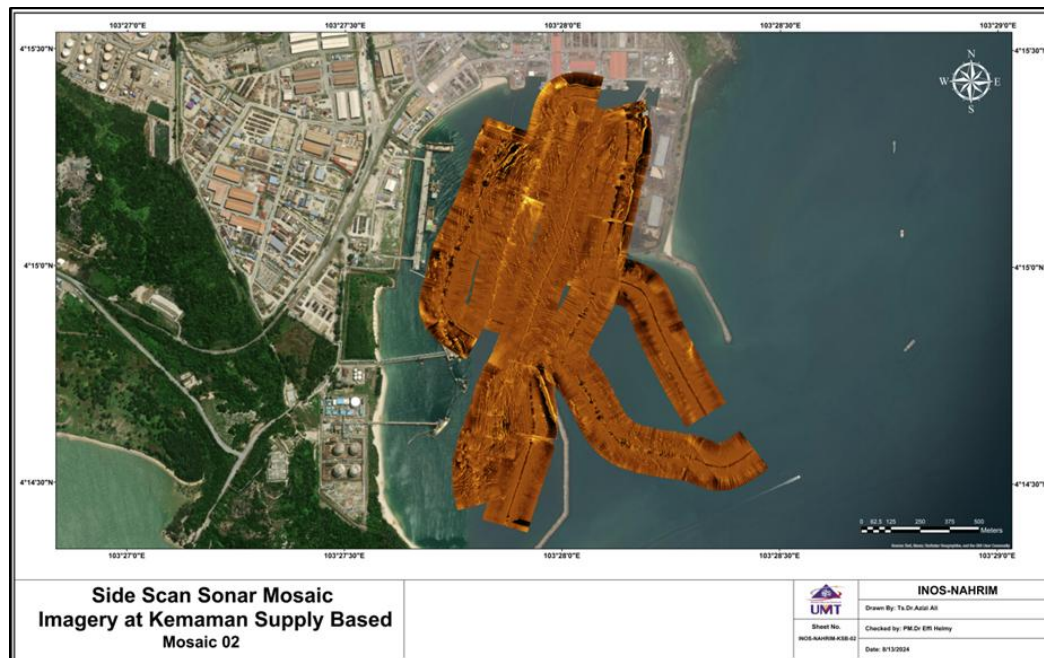
Figure 7. Overview entire study area at Kemaman Supply Based

Figure 7 reveals the presence of clearly defined ripple marks on the seabed, which indicate active bottom currents influencing sediment movement within the port basin. The orientation and spacing of these ripples suggest that hydrodynamic forces, likely driven by tidal exchange and vessel-induced flow, are continually shaping the seabed. This dynamic setting promotes the redistribution of fine to medium-grained sediments, particularly in areas with regular vessel traffic.

In summary, the side scan sonar imagery from Figures 7 through 13 provides valuable insights into the spatial variability and dynamics of the seabed within Kemaman Supply Base. The coexistence of active ripple zones, fine sediment deposits, and irregular bed forms reflects a complex interplay between natural hydrodynamic processes and anthropogenic influences. These findings support the need for a strategic sediment management plan, involving targeted dredging, hazard monitoring, and periodic reassessment of sediment transport behaviour to ensure the port remains safe, navigable, and operationally efficient.

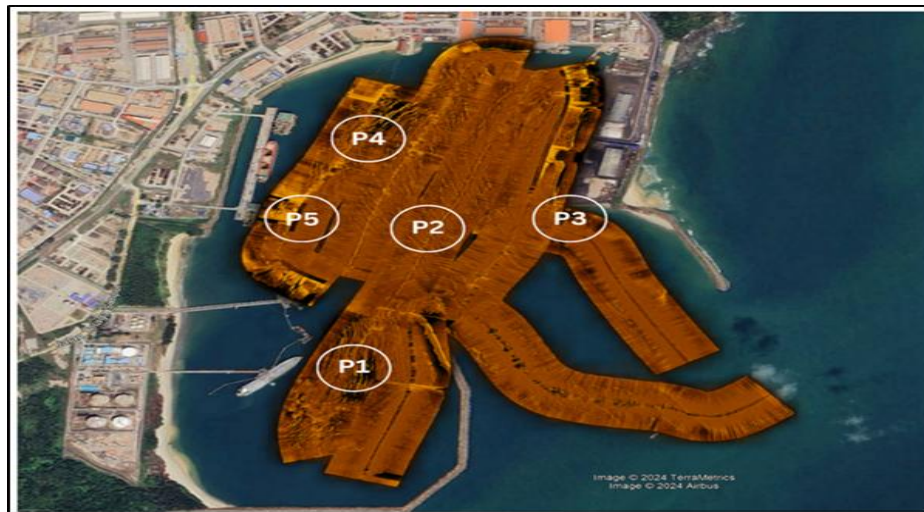
Figure 8. Enlarge image of KSB Port

Moving to Figure 8, the imagery shows a dense concentration of sand ripples in a likely vessel transit corridor. The repetitive ripple patterns further reinforce the presence of strong near-bottom currents, potentially intensified by the propulsion systems of docking or manoeuvring ships. This area appears to be subject to repeated disturbance, resulting in a well-sorted and mobile seabed surface. The presence of active sediment movement in this zone suggests that periodic monitoring is necessary to mitigate risks associated with shoaling and reduced water depth.
