## DEBRIS FLOW: SABO INFRASTRUCTURE AS MITIGATION APPROACH

**Ir. Liew Yuk San**  
National Water Research Institute of  
Malaysia (NAHRIM)

**Ir. Ts. Gs. Dr. Safari Mat Desa**  
NAHRIM

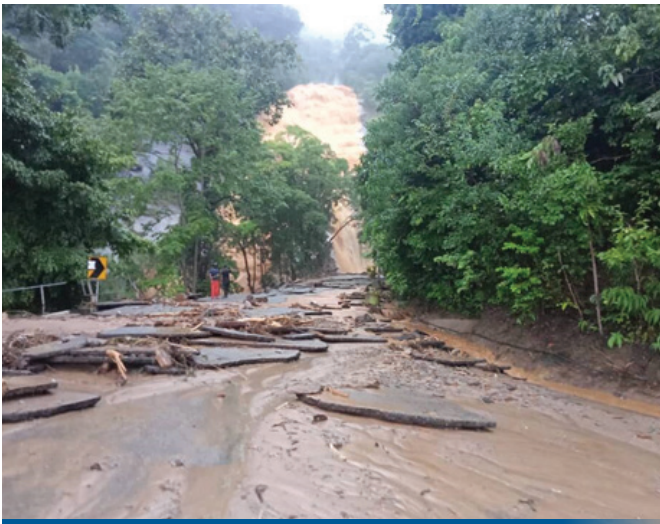
Figure 3: The Debris Flow Situation at the Disaster Location (Source: DID, 2021)

Consequently, Yan and Kuala Muda districts were hit by debris flow near Mount Jerai, causing significant damage to popular tourist destinations including Titi Hayun Recreational Forest, Batu Hampar Recreational Park in Yan District, and Tupah Recreational Forest in Kuala Muda District. The event occurred due to a sudden increase magnitude of waterfall near Mount Jerai, resulting in mud floods in Kuala Muda and Yan measuring between 0.1 to 0.3 meters and 0.2 to 1.5 meters respectively. Debris mainly from geological shift, landslide, boulders and log has obstructed the river crossings, thus inundated into neighboring communities such as Kampung Tupah and Taman Tupah. The debris flow resulted in 6 fatalities, the evacuation of 258 individuals from 72 households, and losses amounting to RM75 million (JMG, 2023). Figure 2 depicts basic geological data, as well as landslides and debris flow occurrences at Mount Jerai. Figures 3 to 4 display images of the mud flow at the disaster location. The impacted areas consist of the foothills of the mountain and the surrounding river areas, such as Seri Perigi, Terai Bukit, Singkir, Kampung Permatang Keramat, Kampung Lubok Boi, Pekan Yan Besar, Titi Teras, Kampung Acheh, and Kampung Setol. Figure 5 demonstrates the contrast between the situations in Hutan Lipur Titi Hayun, Yan District, Kedah, both before and after the mud flood.

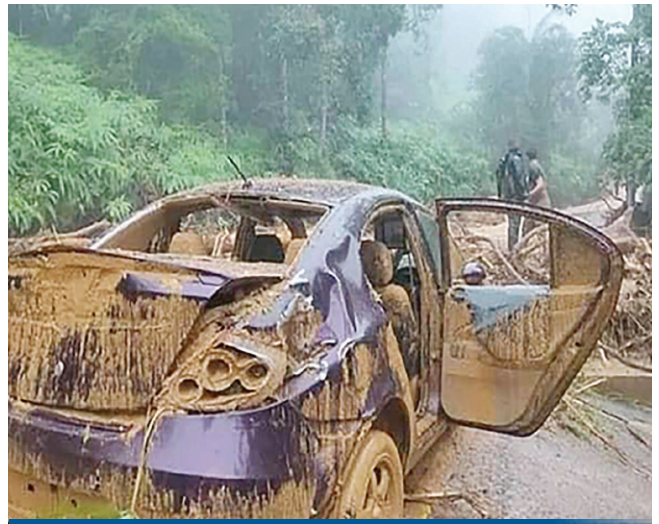
Figure 4: The Debris Flow Situation at the Disaster Location (Source: DID, 2021)

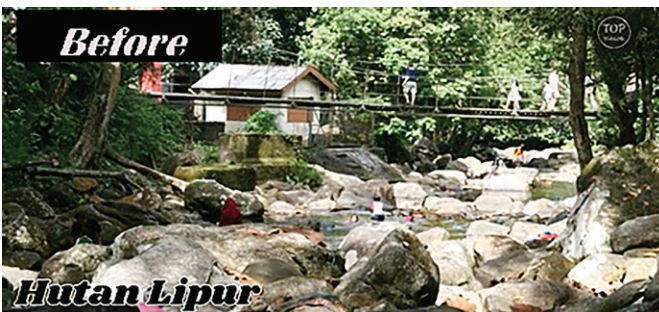
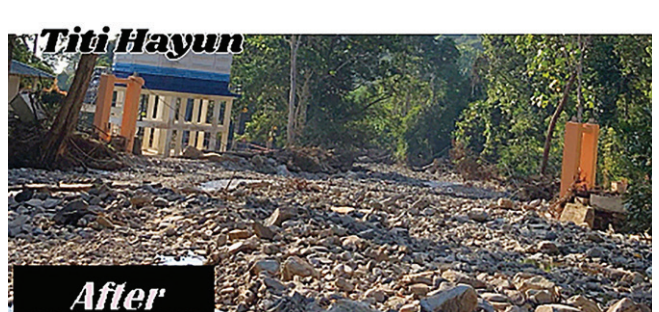
Figure 5: Comparison between the Situations Before and After the Mud Flood in Titi Hayun Recreational Forest, Yan District, Kedah (Source: NAHRIM, 2021)

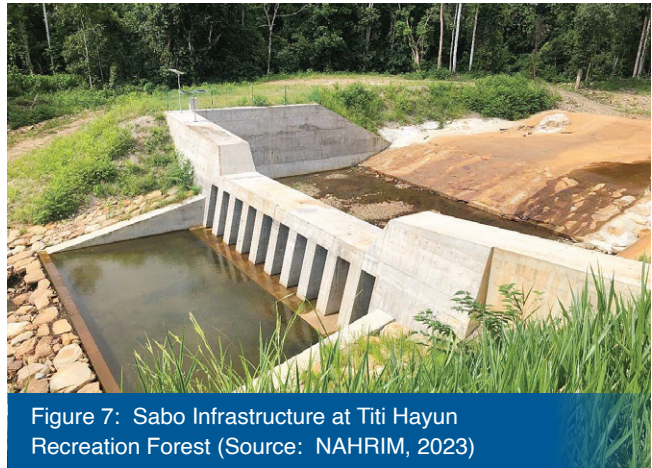
Figure 7: Sabo Infrastructure at Titi Hayun Recreation Forest (Source: NAHRIM, 2023)

Since October 2021, DID has initiated the design and construction of Sabo Infrastructures at two (2) sites near Mount Jerai namely Titi Hayun Recreational Forest and Bujang River, Tupah 1 at the SADA Water Treatment Plant. The Sabo Infrastructure at Titi Hayun Recreation Forest was completed in June 2023 and displayed in Figure 7.
