PROJECT NO.: P33 17000 012 0003 (*Skop 2*)

FINAL REPORT  
MIRI, SARAWAK GIS AND MARINE DATA  
OCTOBER 2022

**FINAL REPORT**  
**MIRI, SARAWAK GIS AND MARINE DATA**  
**OCTOBER 2022**

**NAHRIM.PKPO.1/2022**

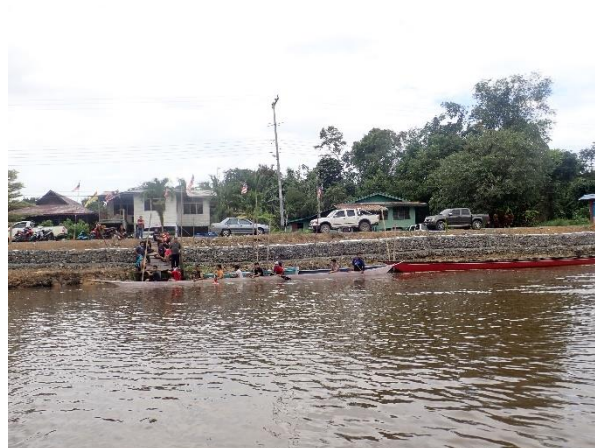
Figure 3: Some revetments were builded to protect Niah's River Bank

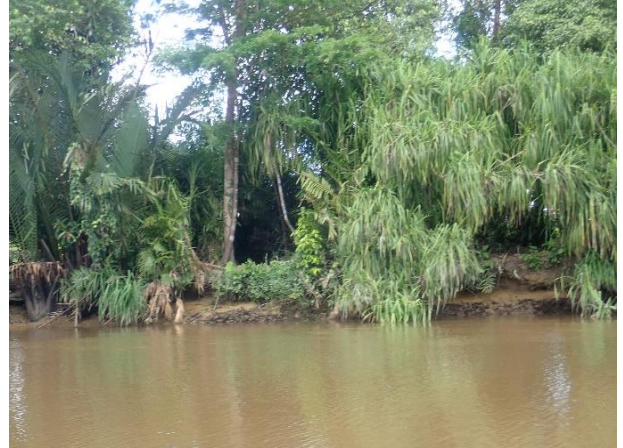
Figure 29: Some hard protections were observed to protect the river bank

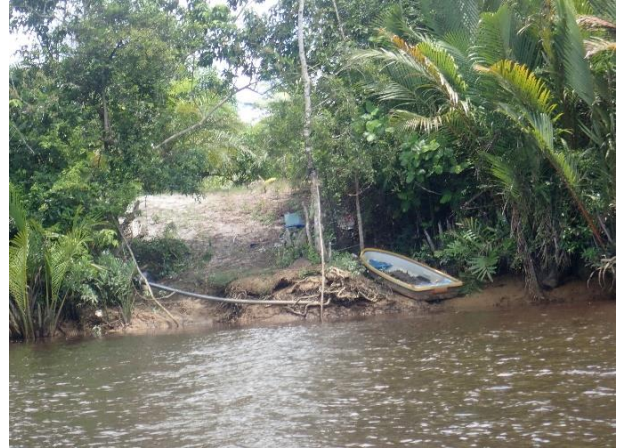
Figure 35: High erosion of river bank and produced flood prone areas

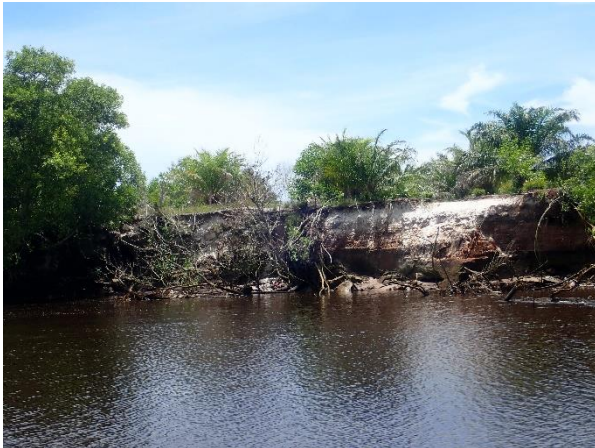
Figure 36: High erosion of river banks and also associated with died plants and trees

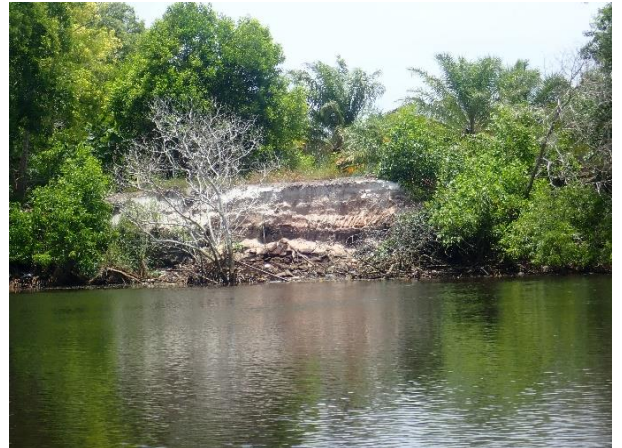
Figure 37: High erosion of river banks and also associated with died plants and trees

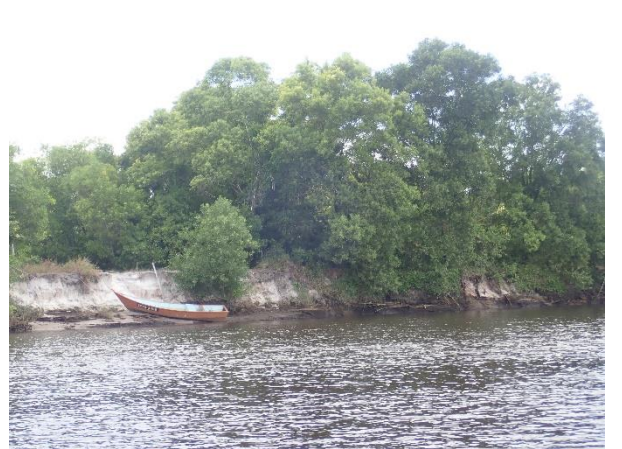
Figure 39: High erosion of river banks

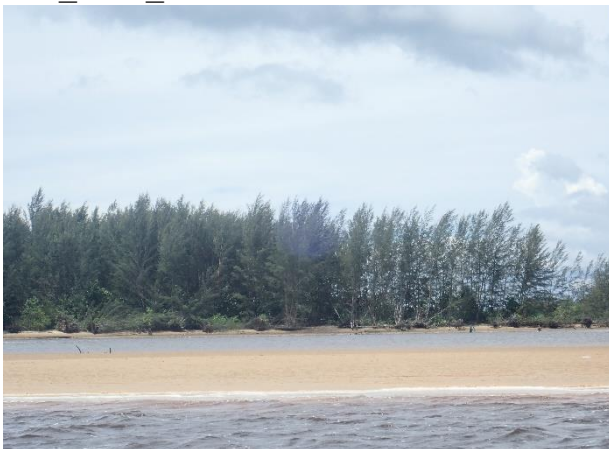
### **GIS\_Niah\_01**

Figure 44: The sand tombolo was developing at Niah river estuary. Some high magnitude of wind strees at this area

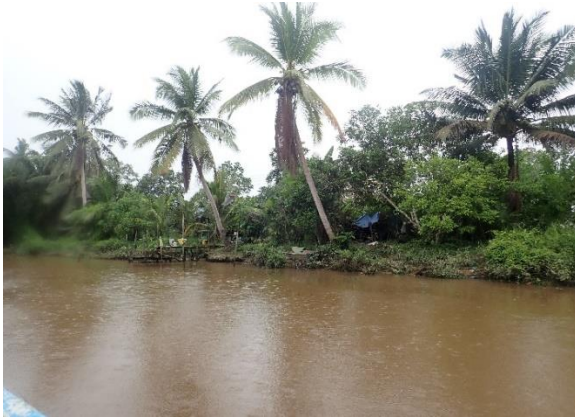
### GIS\_Sibuti\_20

Figure 51: The moderate erosion of river banks adjacent to local residents house

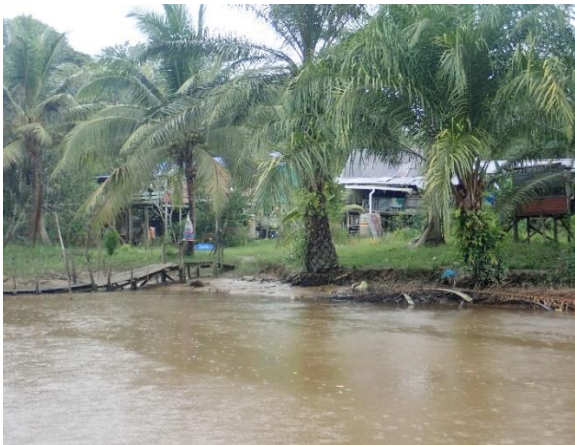
### GIS\_Sibuti\_19

Figure 53: The destroyed jetty and Palm Oil plant were observed in this area

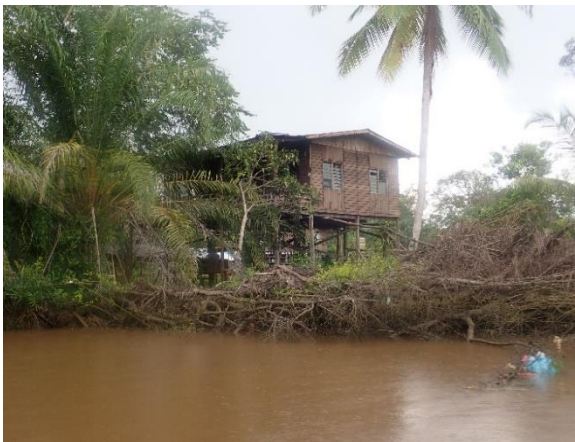
### GIS\_Sibuti\_18

Figure 55: Destroyed of plants due to river bank erosion

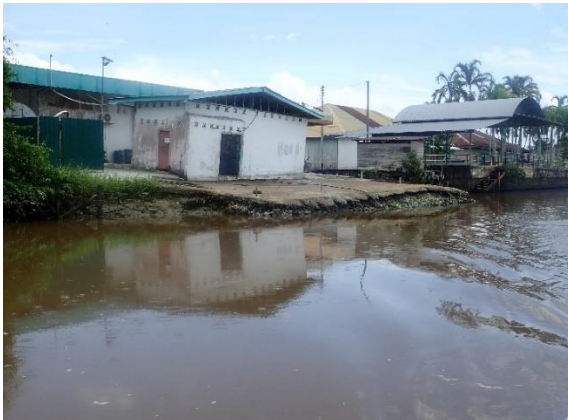
### **GIS\_Sibuti\_15**

Figure 61: The roads were destroyed and vulnerable to fuel pump stations near to river banks

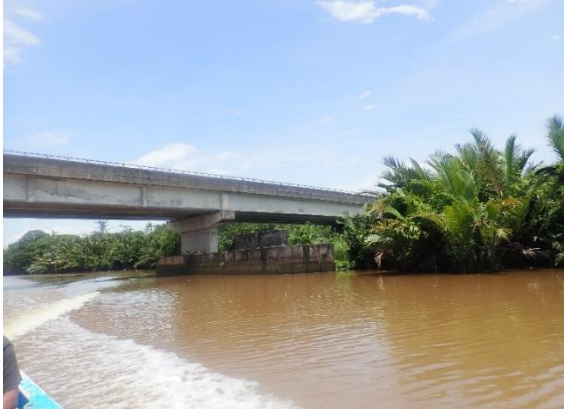
### GIS\_Sibuti\_14

Figure 63: The bridge to connected two villages

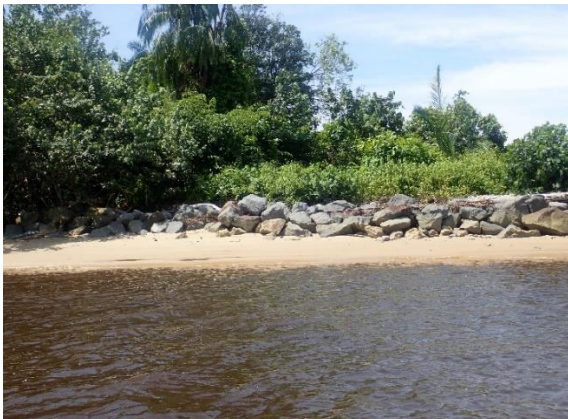
### **GIS\_Sibuti\_01**

Figure 73: The hard structures were build as revetment to protect river estuary

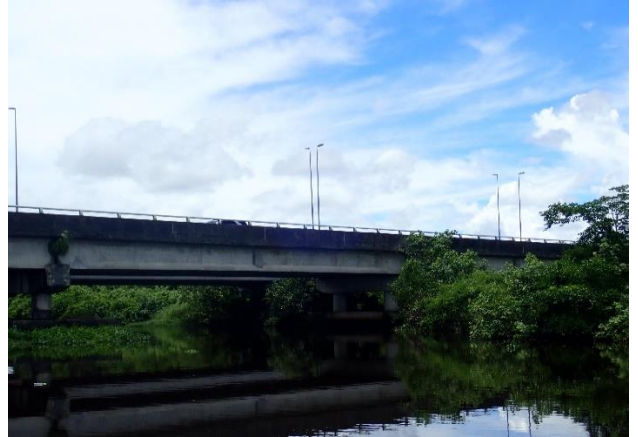
## GIS\_Baong\_12

Figure 91: The bridge to connected two villages

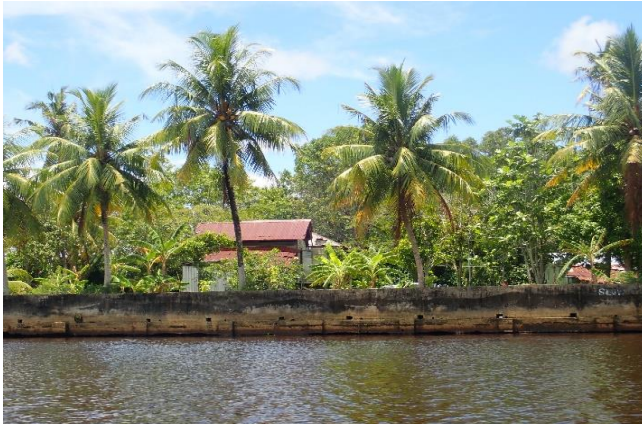
## GIS\_Baong\_08

Figure 94: The river bank structue as revetment to protect river bank erosion

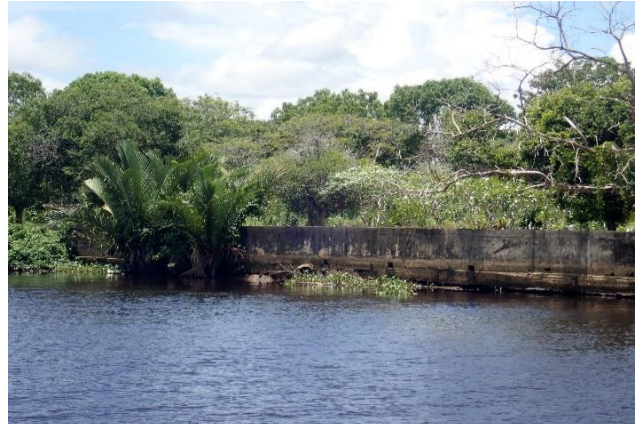
Figure 95: The river bank structue as revetment to protect river bank erosion

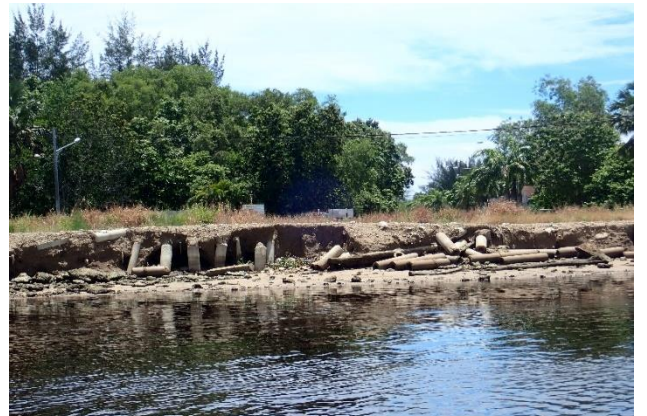
### GIS\_Baong\_04

Figure 99: Very worst erosion near to river bank and vulnerable to district roads

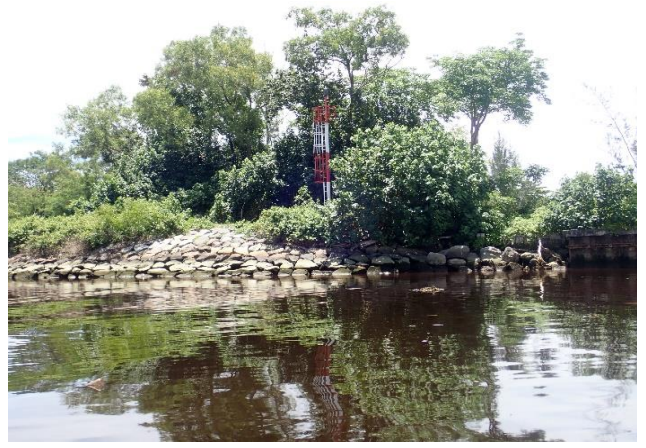
## GIS\_Baong\_01

Figure 103: The revetments were build to protect river estuary erosion

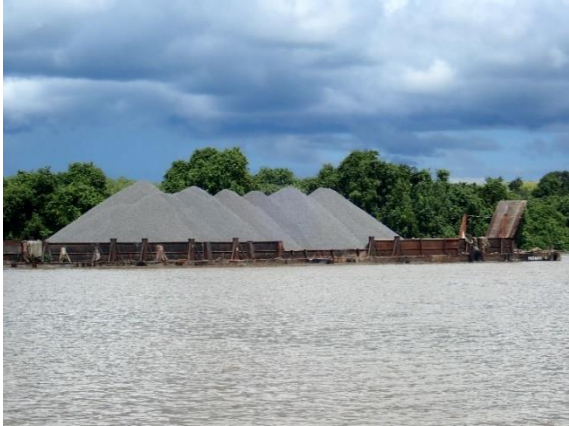
### **GIS\_Baram\_08**

Figure 113: The sand dredging activity was observed along the river

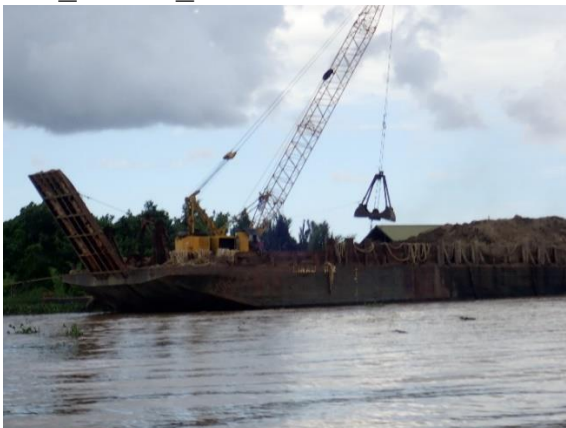
Figure 121: The sand dredging activity was obseved. The sands were logisticted to the boat by the big crane
